Performance on the Platform

**Portadown,
Northern Ireland**

Translink

August 2024

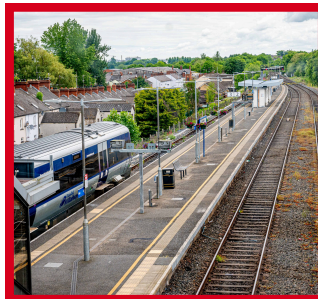
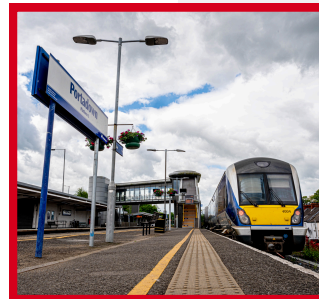
Translink, the public corporation responsible for Northern Ireland's transport network, encountered a significant challenge due to a severely deteriorated bituminous platform. The surface was badly pitted and spalled, creating potential safety hazards for passengers.

To resolve the issues with the ageing platform, a tailored solution using three specialist products was implemented. Prismo® ScratchLock™, Robur® Grip, and Prismo® Regulatory Preformed Thermoplastic were selected for their compatibility with hand application and fast-curing properties, allowing for a safe and efficient refurbishment.

The works were completed overnight to avoid disruption to services, and the platform was ready for use by morning. This approach delivered a durable, low-impact upgrade with minimal interruption to daily operations.

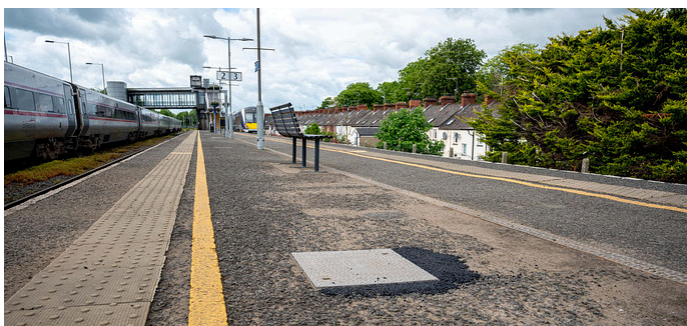
The aged platform surface was pitted and spalled.

Due to the platform's age and condition, conventional resurfacing machinery was unsuitable as its weight and pressure risked causing further damage. With the platform in regular use, keeping disruption to a minimum was essential.

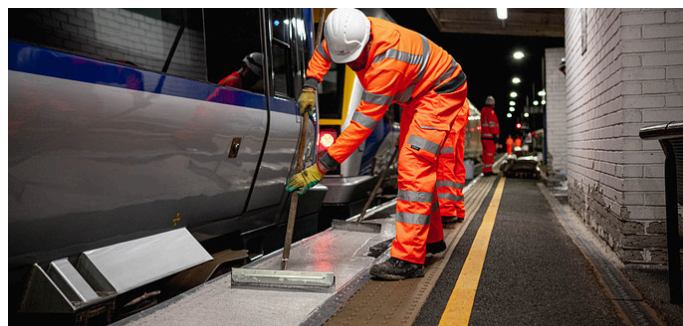
Layer of Prismo® ScratchLock™ applied with a flat squeegee to level the surface.

Prismo® ScratchLock™

Seamlessly restored the platform, ensuring a smooth, level finish for improved performance.

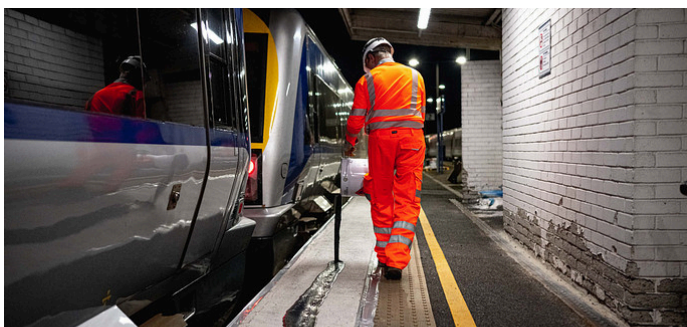
Robur® Grip applied as an anti-slip top coat in black.

Robur® Grip MMA

Provided a sleek, anti-slip top coat that not only improved safety but also enhanced the overall appearance of the platform.

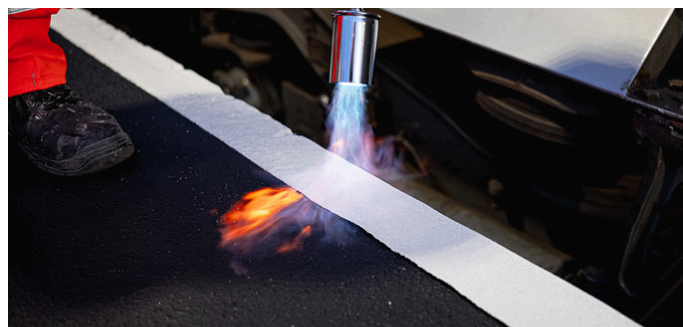
Prismo® Regulatory Preformed Thermoplastic was used to delineate the platform edge.

Prismo® Preformed

Delivered a durable, anti-slip marking that clearly outlined the platform edge, improving safety for passengers getting on and off the train.
